SERVICE BULLETIN

KAIR10001 – TANARG Fuel Tank

Re : Potential cracks in TANARG fuel tanks.

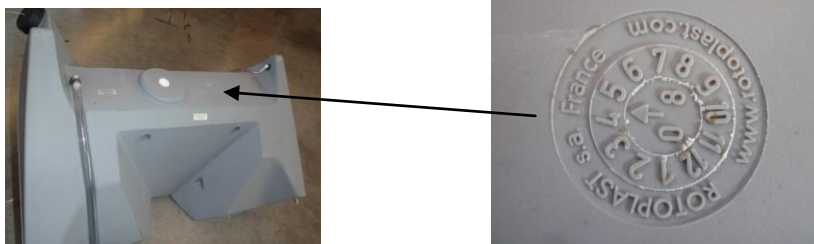
TRIKES CONCERNED : The TANARGs whose fuel tank was manufactured in since January 2008. (stamp visible as shown in the figures hereunder 08-04 or April 2008):

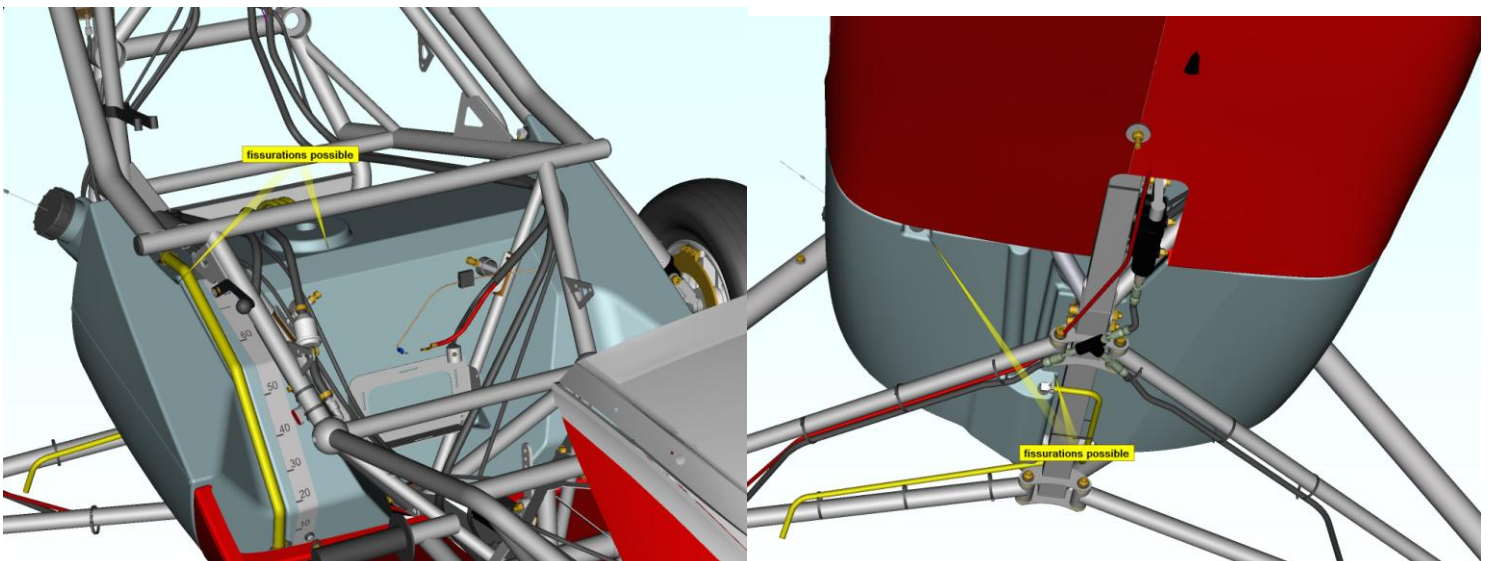
Potential appearance of cracks leading to fuel leaks.

Regular and careful checks must be made and before every flight, in case of the appearance of cracks you should stop flying and contact our aftersales service for a replacement part.

It may prove useful to disassemble the keel of the trike (lower fairing) in order to gain visual access to the areas at risk.
